Backgrounder: Three Phase Power

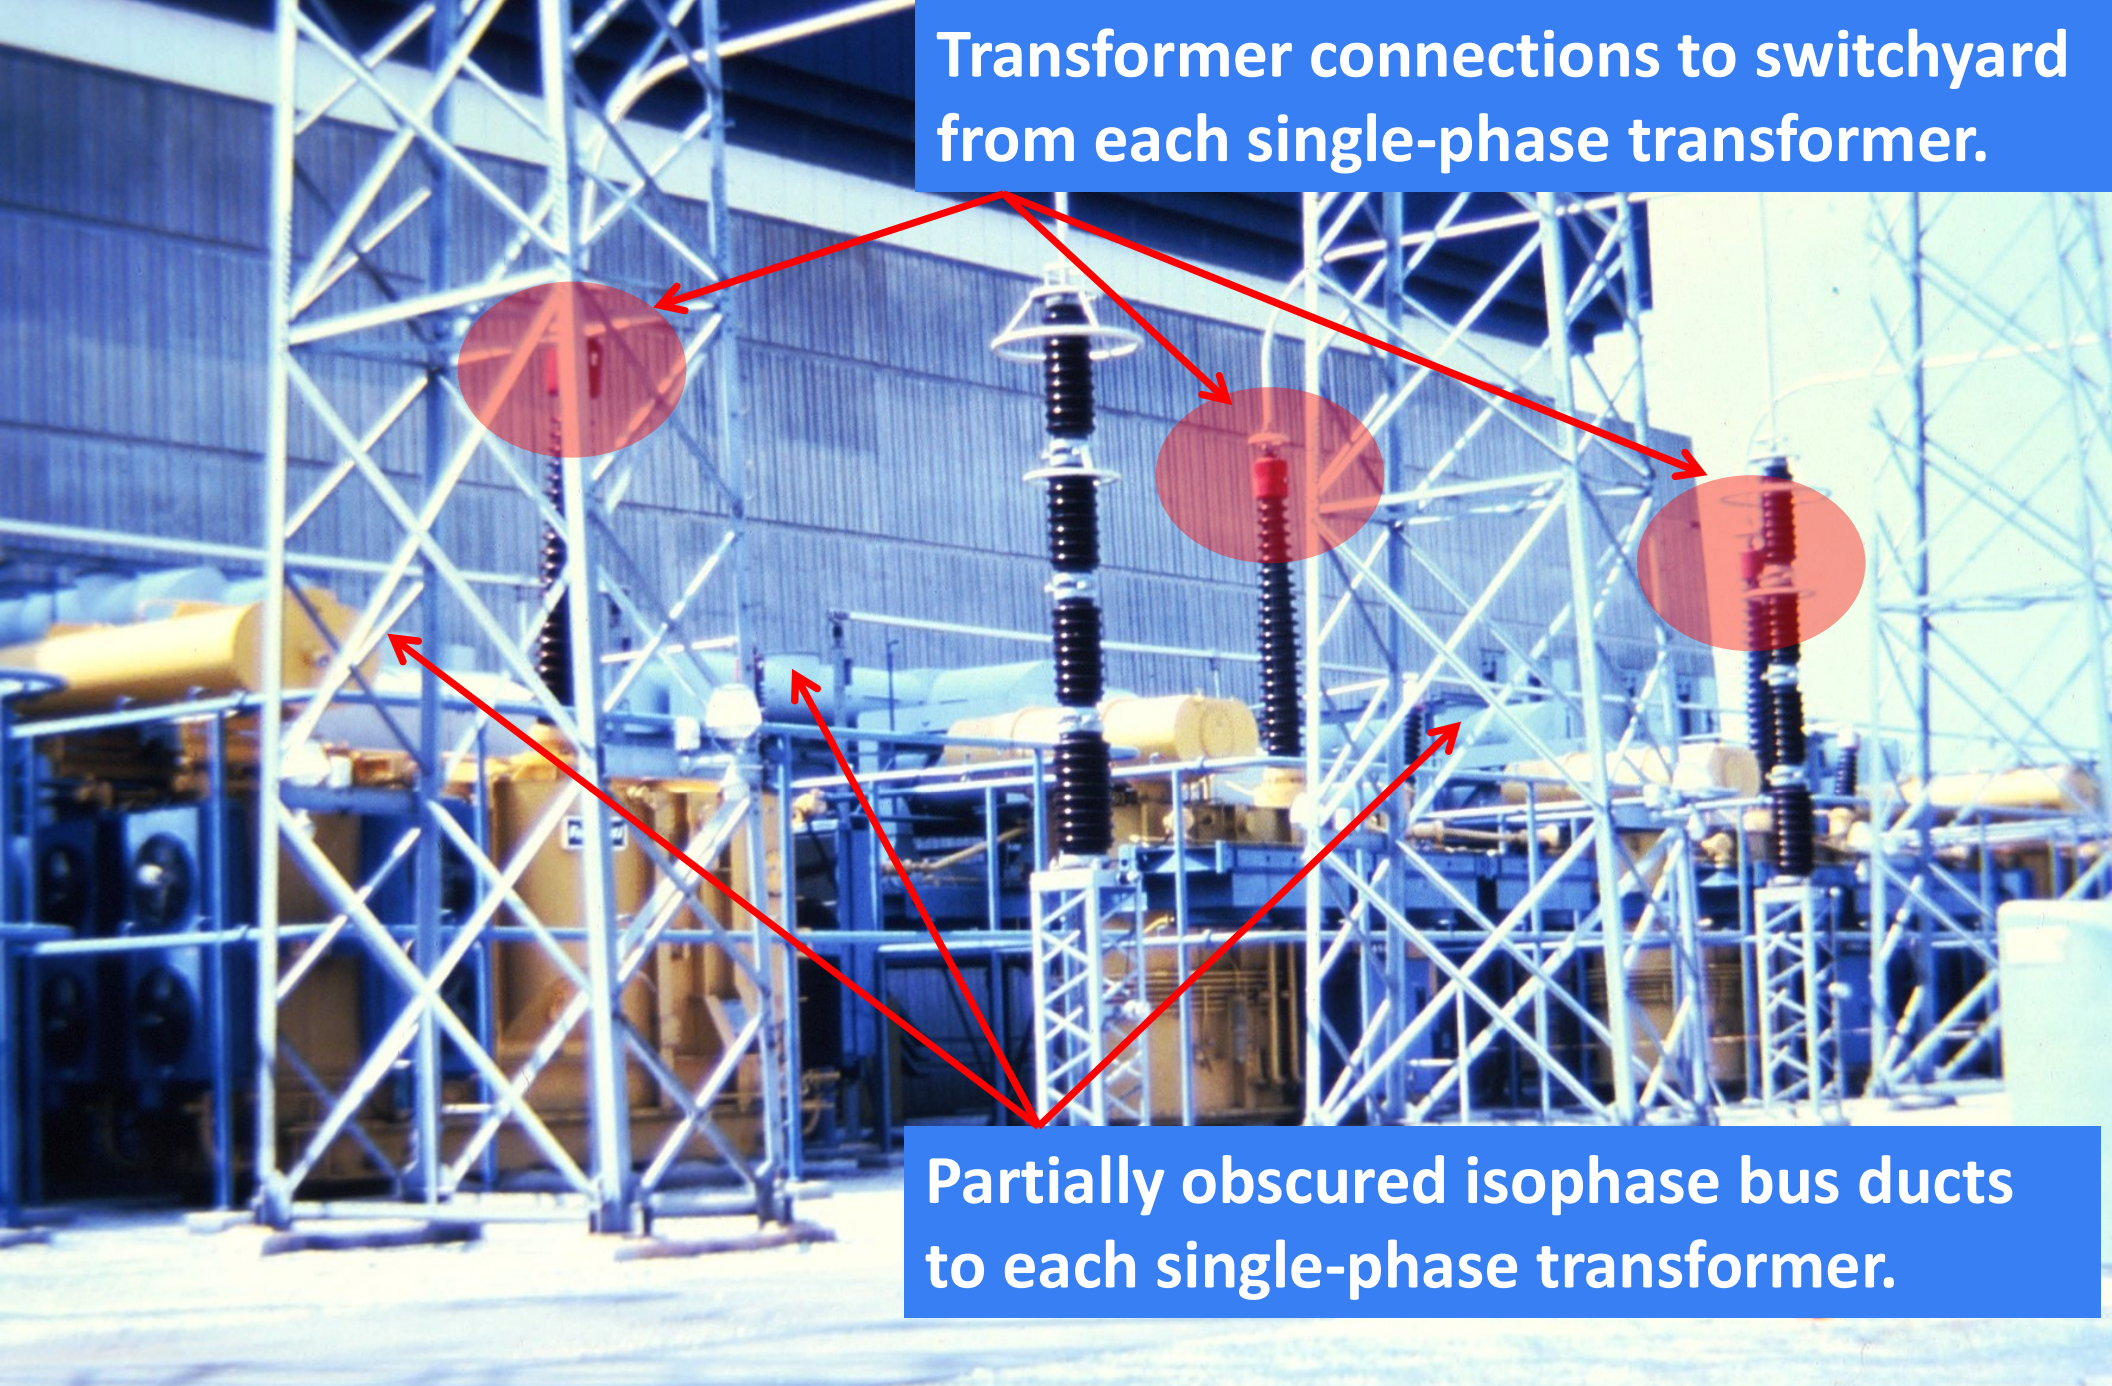
**Transformer
connections to
switchyard.**

Transformer connections to switchyard
from each single-phase transformer.

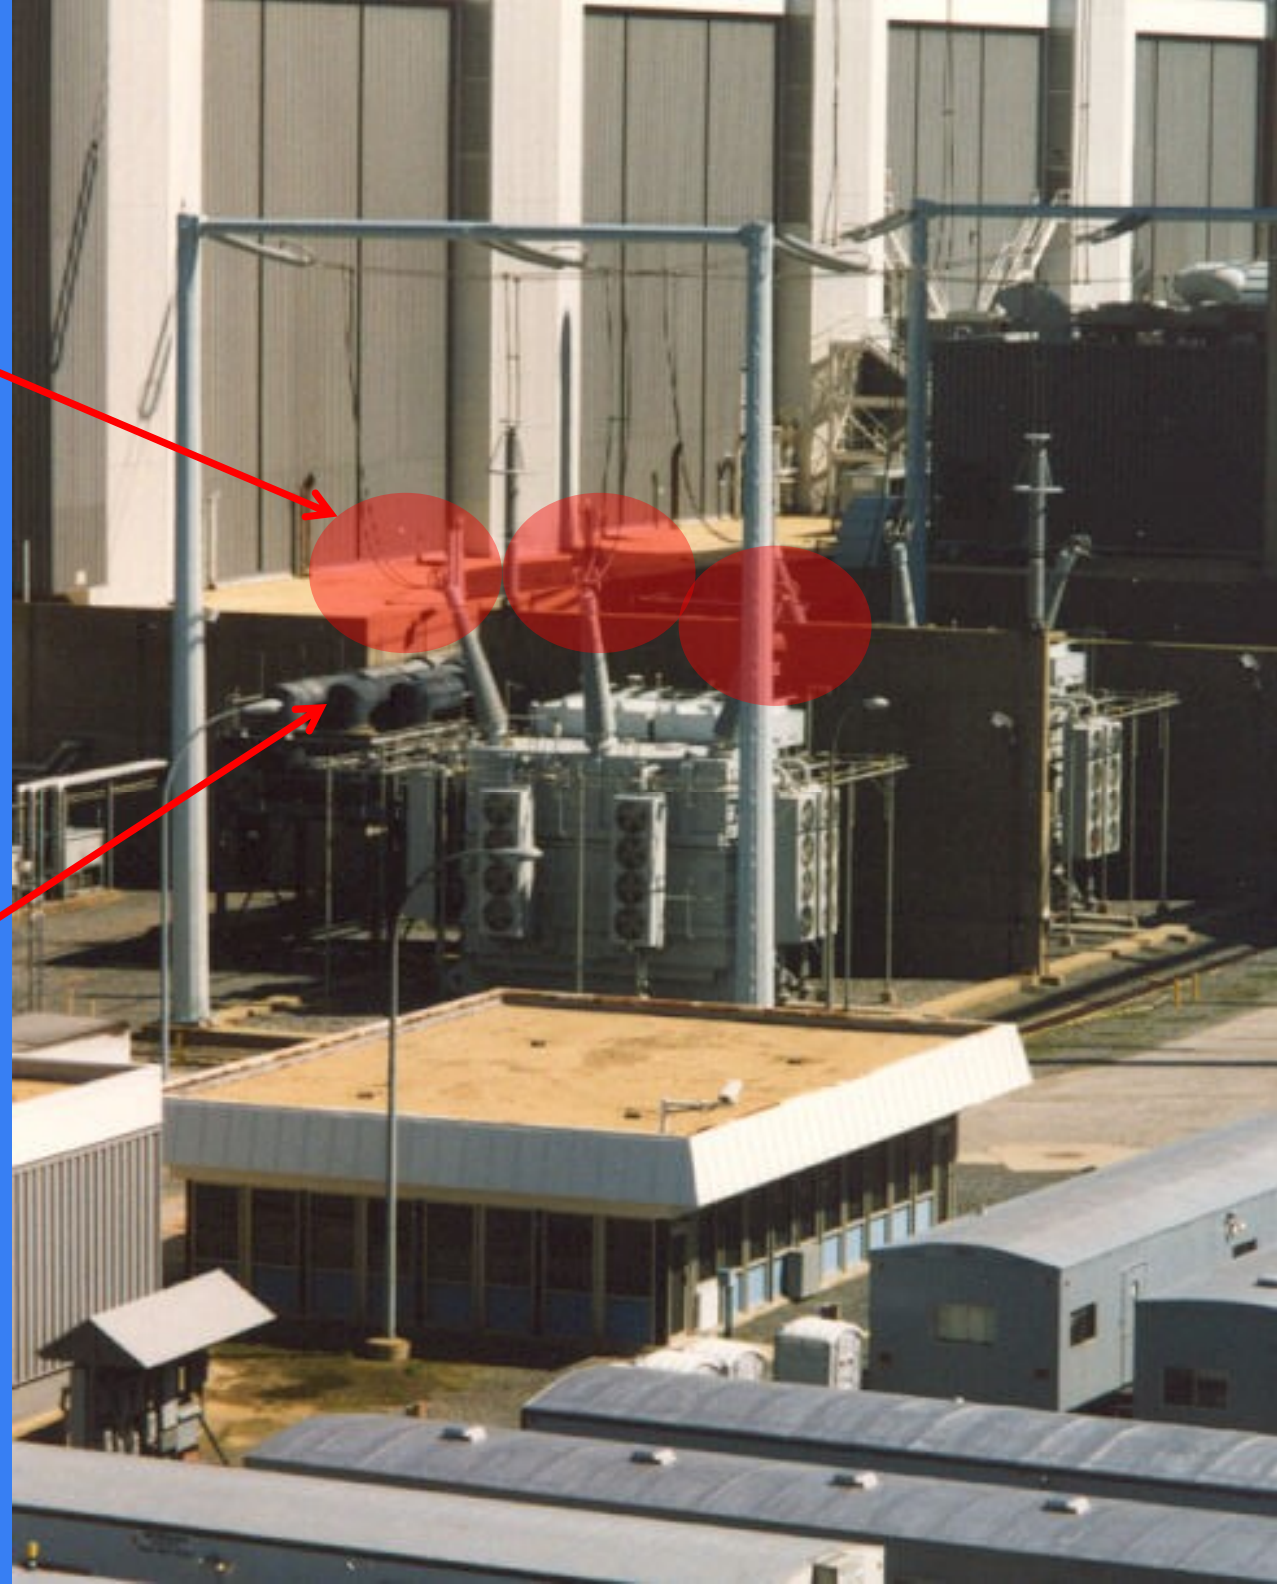
**Partially obscured
isophase bus ducts**

Partially obscured isophase bus ducts
to each single-phase transformer.

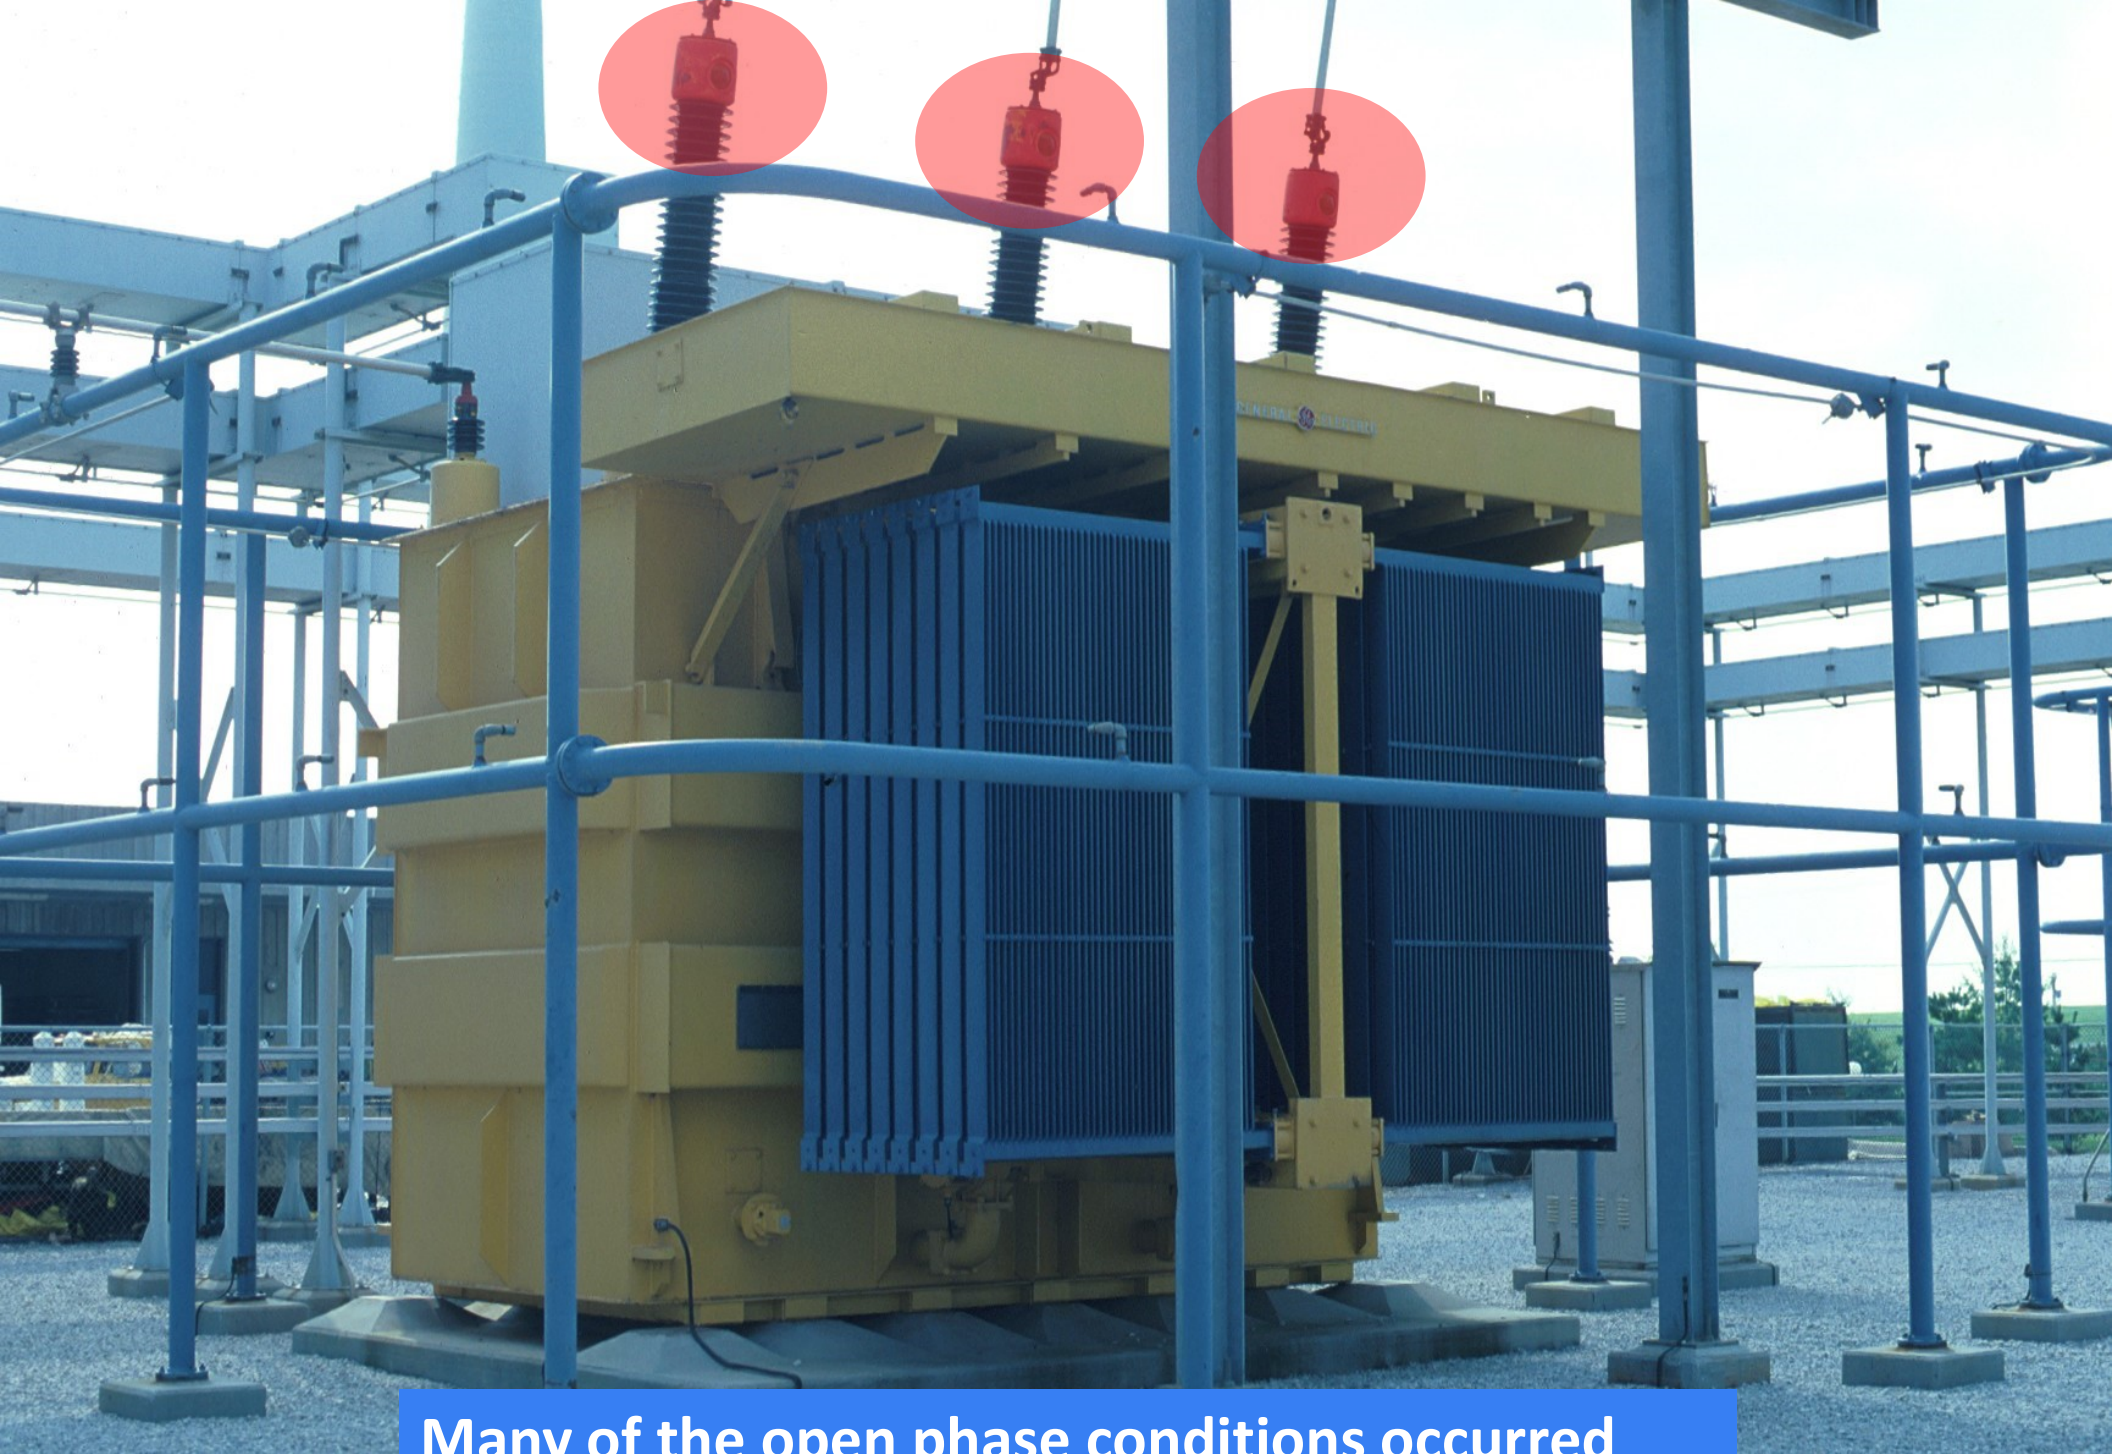
Many of the open phase conditions occurred when one connection to a transformer breaks.

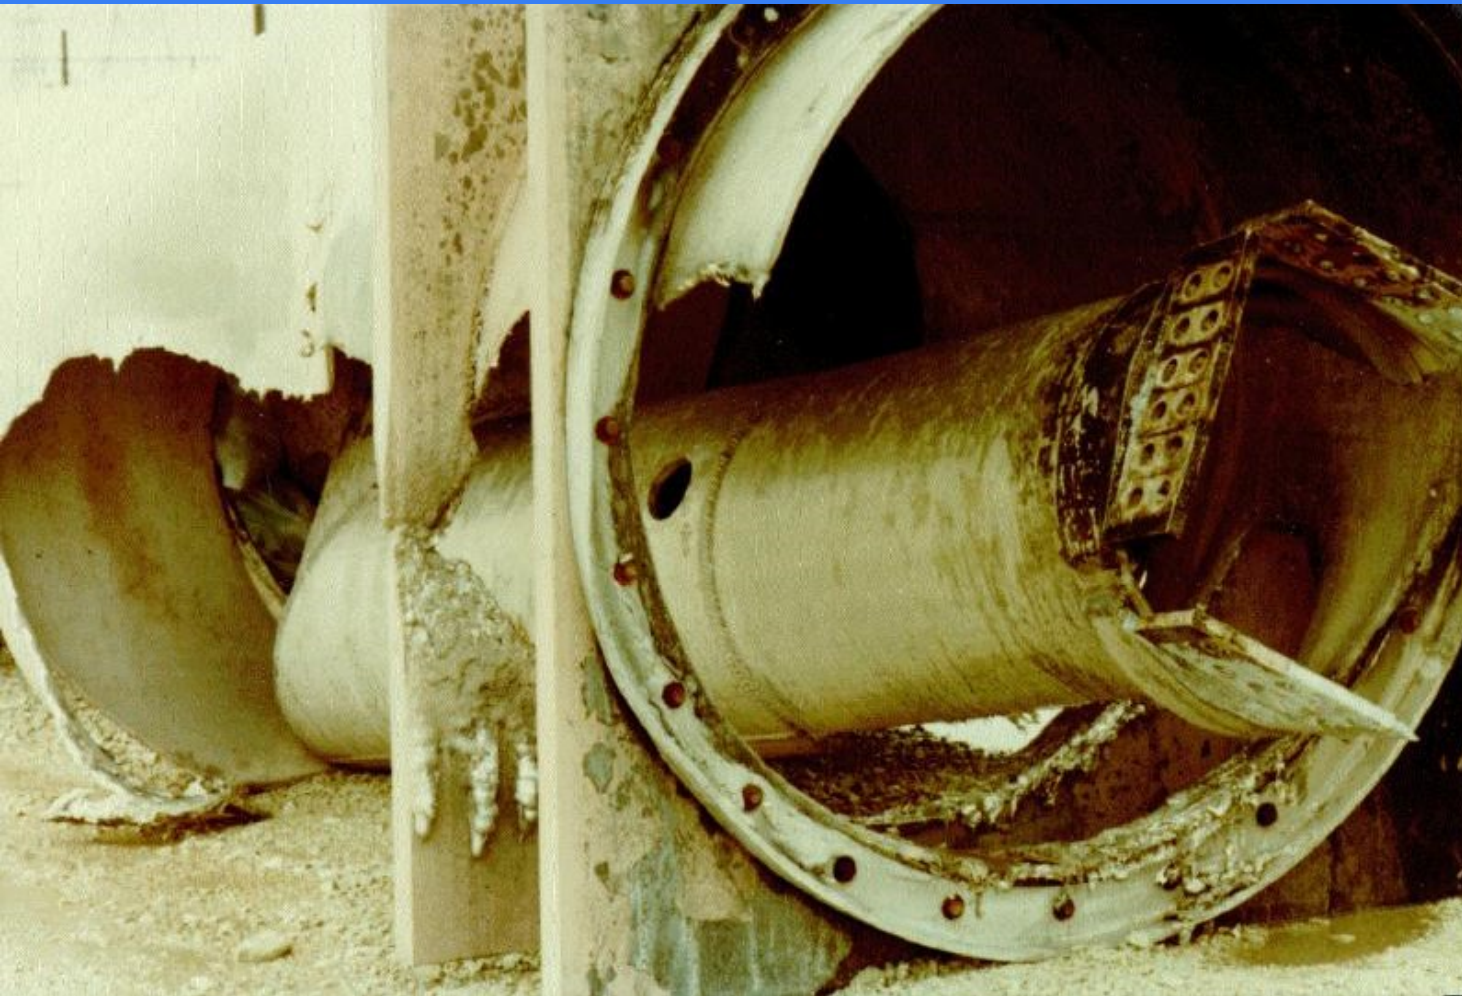
Close view of the miniflux plate area of the A-Phase bus at the transformer. Note the extensive damage to the 2" thick miniflux plate. Also note the temporary clamping ring installed after the first failure to serve as a means to attach the temporary bus duct boot.
