SUBJECT: NRC AUGMENTED INSPECTION TEAM - STEAM GENERATOR TUBE
FAILURE - REPORT NO. 05000247/2000-002

IP2 STEAM GENERATOR TUBE LEAK (2/15/00) RADIOLOGICAL RELEASE PATHS

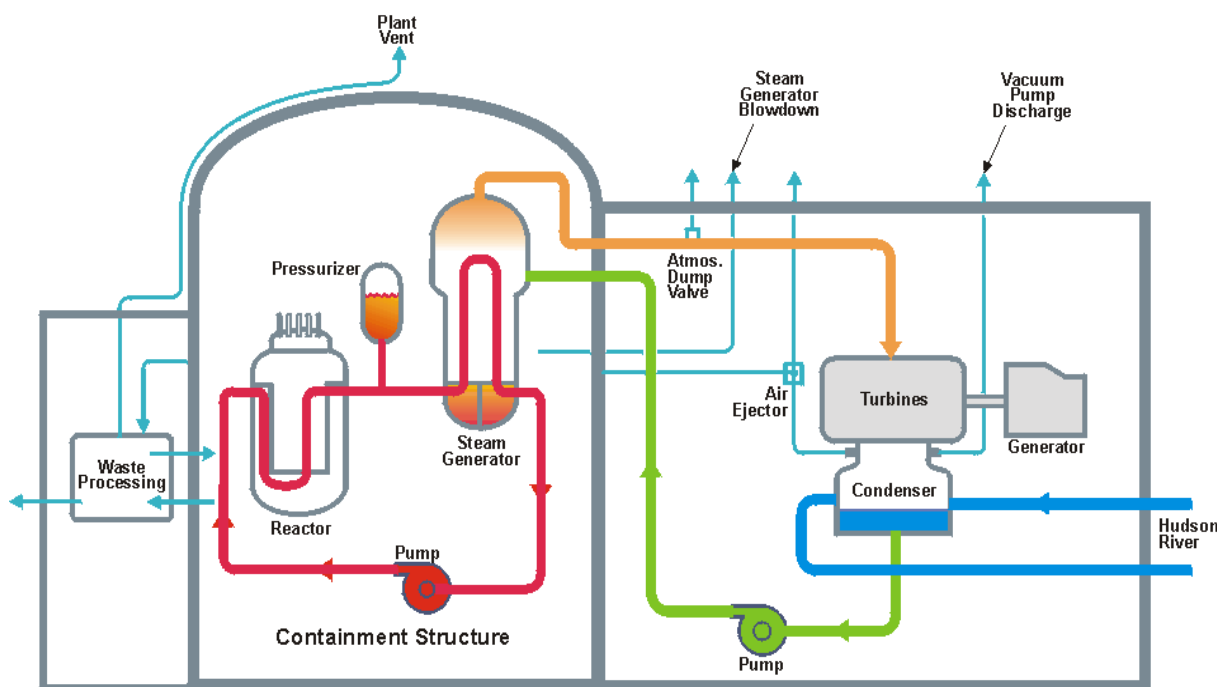
INDIAN POINT 2

Illustration of the Release Paths:

Calculated Release Paths:

Gaseous Releases (Noble Gas: Xenon 133, 135; Argon 41; Krypton 85, 88, 87)

<u>Source of Release</u>	<u>Duration</u>	<u>Amount</u>	<u>Projected Exposure</u>
A. Containment vent	24 hrs	1.50 Ci	4.04E-5 mrem
B. Evacuate condenser (Vacuum Pump)	3 hrs	9.60E-2 Ci	4.50E-3 mrem
C. #24 ASDV (Incl. Iodine fraction, 1E-2)	10 hrs	3.64E-2 Ci	2.19E-3 mrem 3.44E-2 mrem, organ
D. Gland Seal Exhaust	70 mins	5.77E-2 Ci	3.21E-3 mrem 2.20E-3 mrem, organ
E. Secondary steam leaks	10 hrs	2.53E-3 Ci	4.20E-4 mrem 4.40E-3 mrem, organ
F. Initial SJAE	45 sec	7.1E-5 Ci	1.59E-6 mrem
G. #21, #22, #23 ASD	2.7 hrs	2.60E-5 Ci	1.45E-3 mrem, organ

C. Gland Seal Exhaust	5.71E-4 Ci	2.10E-6 mrem, organ
D. S/G #24 Blowdown	5.59E-4 Ci	2.30E-6 mrem, organ
E. S/G #21, #22, #23 Blowdown	2.82E-4 Ci	3.00E-6 mrem, organ
F. Secondary side leaks	5.80E-6 Ci	1.30E-6 mrem, organ
<u>TOTAL:</u>	<u>1.38E-2 Ci</u>	<u>9.20E-4 WB, 1.51E-3 mrem, organ</u>
